Technical Assistance Report

The Pasion River Fish Kill Investigation

Sayaxche, El Peten, Guatemala

SESD Project ID No. 15-0383

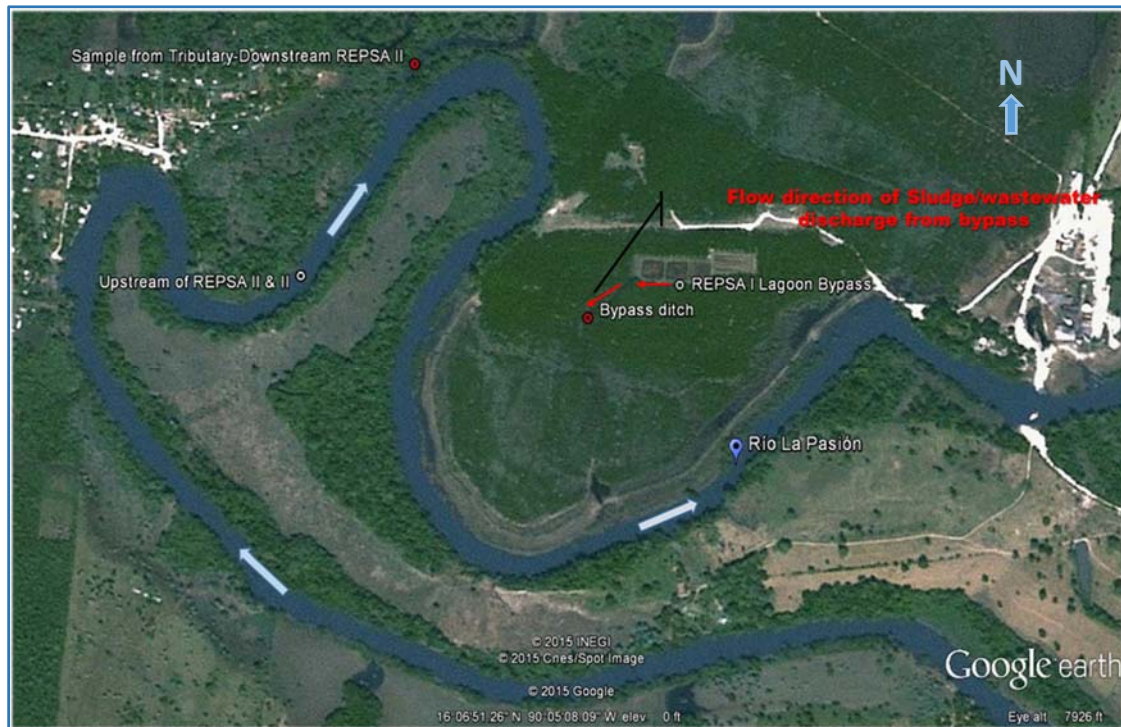
Figure 1: REPSA I Oxidation Lagoon Bypass Location

EPA observed that the wastewater/sludge discharged from the bypass pipe was dark gray in color and had an oily like appearance. Refer to Photos 2 through 5, pages 17-19, for details. **Figure 1** shows the location of the anaerobic lagoon bypass and the direction of the wastewater/sludge discharge.

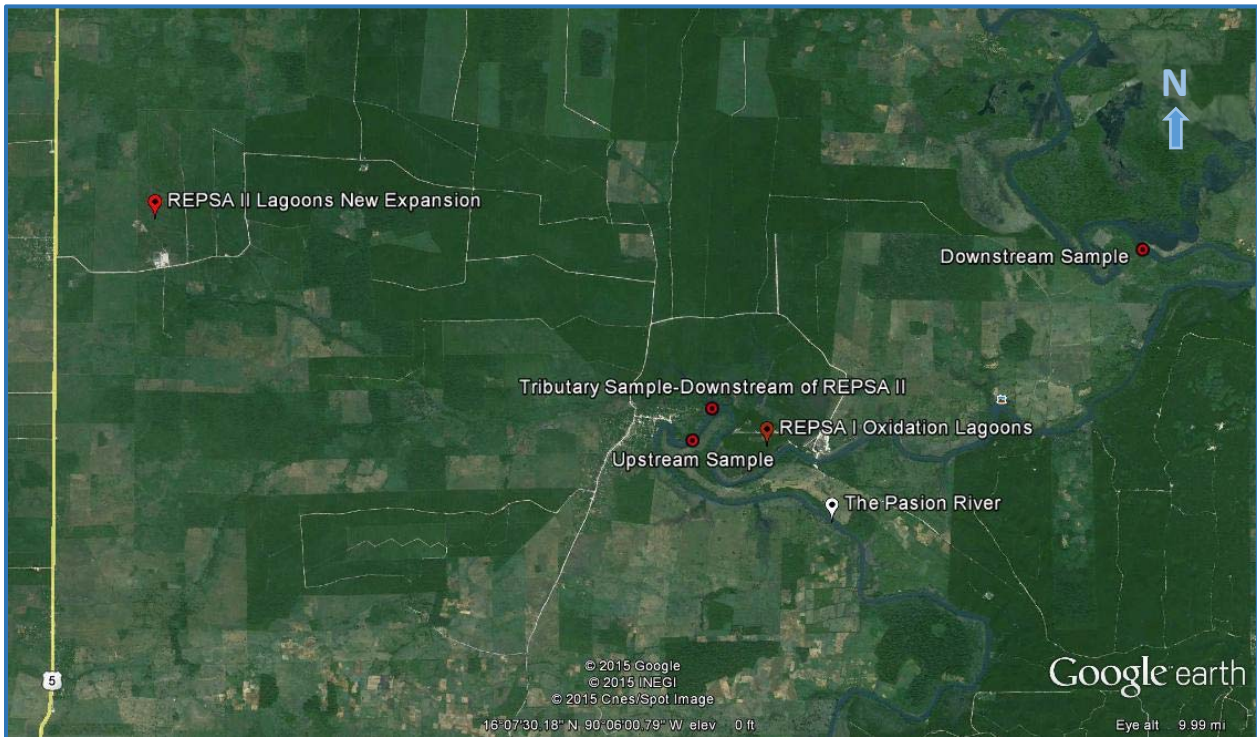
Figure 2: The Pasion River Sample Locations

MARN collected three surface water samples from the Pasion River (See **Figure 2, page 9**). Samples were collected for BOD₅, chemical demand oxygen (COD), TSS, metals, phosphorus, total nitrogen, oils and grease, fecal coliforms, total cyanide, and color analyses. Analytical results were not available at the time of the completion of this report. Upon completion of the analytical results, the results and their interpretation will be provided in an additional report. **Figure 2** describes the sample locations. **Table 2** includes the EPA field measurements collected in the three sampling locations.

The Pasion River Field Measurements				
Station ID	River Downstream	Tributary	River Upstream	
Sample ID	Station 006	Station 007	Station 008	
Matrix	Surface Water	Surface Water	Surface Water	
Sample Date/Time	07/07/2015 12:00	07/07/2015 13:10	07/07/2015 13:30	
Analyte	Units			
pH	S.U.	7.75	7.74	7.72
DO	mg/L	5.72	5.72	5.56
Specific conductance (conductivity)	umhos/cm	302	306	301.9
Temperature	°C	26.83	27.07	26.62

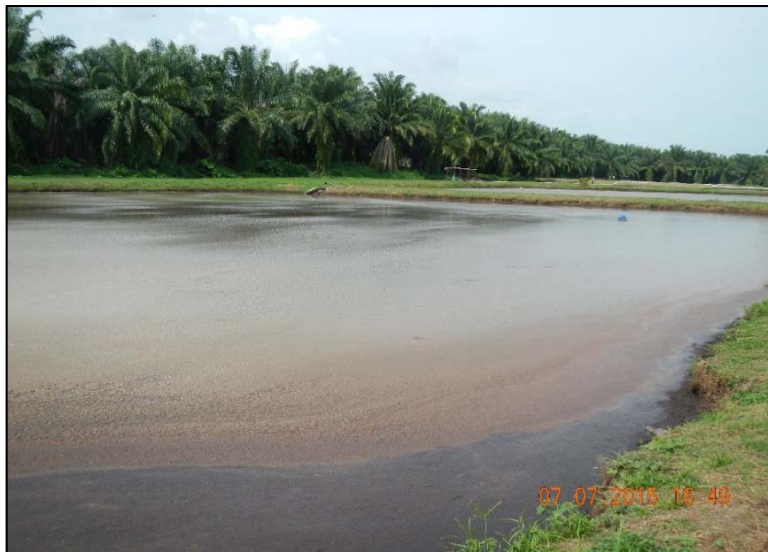
Photo No:
1

During the EPA visit, it was observed that the REPSA I lagoons were almost full to capacity, with a free board of approximately one foot (0.3 meters) (See photo 1, page 17). Typically, lagoons should have a minimum freeboard of 0.9 meters (3 feet) (USEPA, 2002). The minimum freeboard design criteria is recommended in an effort to avoid or minimize overflow during rain events of significant magnitude. In addition, EPA and MARN detected a very strong hydrogen sulfide odor similar to rotten eggs originating from the lagoon treatment system. At the time of the inspection, REPSA I was discharging untreated anaerobic sludge through a 15-cm (6-in) bypass pipe from the bottom of the anaerobic lagoon into an open channel area (See photo 2, Page 17). This bypass practice may short-circuit the hydraulic flow of the treatment process and

Description:
View of REPSA I's anaerobic lagoon where the bypass was observed. Lagoon was in full to capacity with a freeboard of approximately one foot.

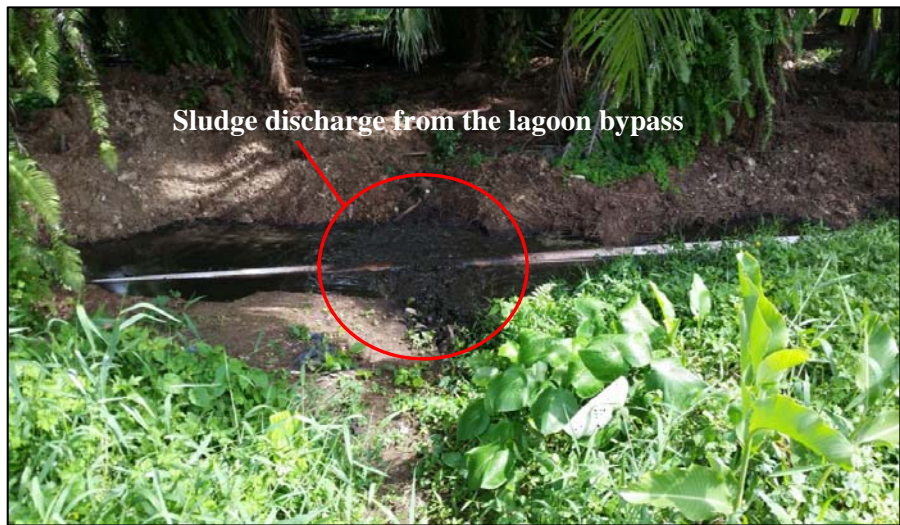
Photo No:
2

consequently adversely impact the overall treatment of the wastewater. Typically in this type of system, higher concentrations of contaminants are found in the bottom of the lagoon. Consequently, the bypass was discharging potentially the highest concentrations of contaminants outside of the wastewater reuse system. According to MARN's inspectors, REPSA also had not submitted to MARN its Environmental Assessment Instrument to evaluate the environmental impacts of its operations in the area, including an evaluation of the criteria used for the design of the oxidation lagoons. Since REPSA only had authorization to reuse the treated wastewater in the authorized irrigation fields, then this type of practice violated the Government Agreement 236-2006, Articles 34 (Wastewater Reuse Parameters), 55 (Disposal Prohibition of Wastewater), and 56 (Direct Discharge Prohibition), and therefore, can be considered an illegal discharge.

A dark brown, almost blackish wastewater/sludge is a sign of anaerobic conditions (low levels of dissolved oxygen) (USEPA, 1977). Wastewater generated from palm oil processing is also known as Palm Oil Mill Effluent (POME). POME, when fresh, is a thick brownish colloidal mixture of water, oil and fine suspended solids. It is hot (80-90°C) and possesses a very high BOD₅, which is non-toxic as no chemicals are added to the extraction process (Khalid & Wan Mustafa, 1992; Ma et al. 1993). POME is also acidic with a pH of around 4.5 (Madaki, Seng, 2013).

Description:
View of the bypass discharging anaerobic sludge into a ditch. The bypass was discharging sludge when EPA-MARN arrived at the plant.

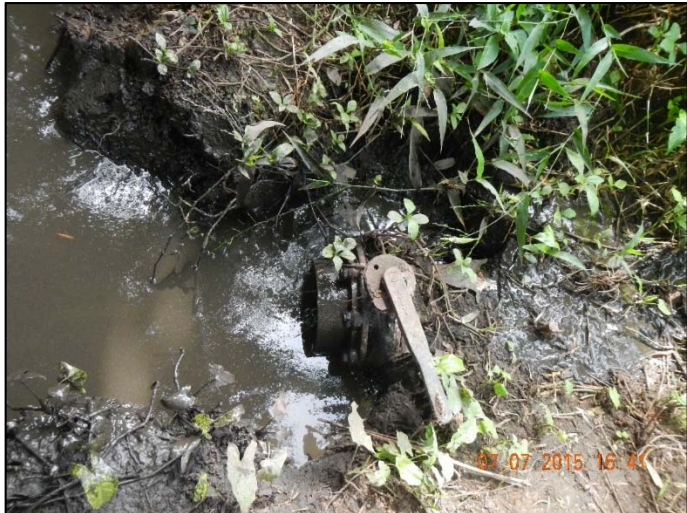
Direction Photo Taken: West			
Description: View of the six-inch bypass with the valve closed.

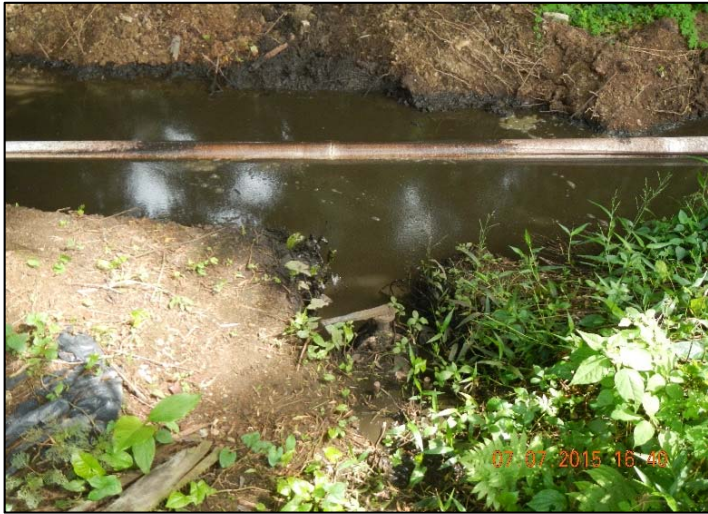
Direction Photo Taken: South			
Description: View of the stagnant sludge on the ditch after REPSA personnel closed the valve.

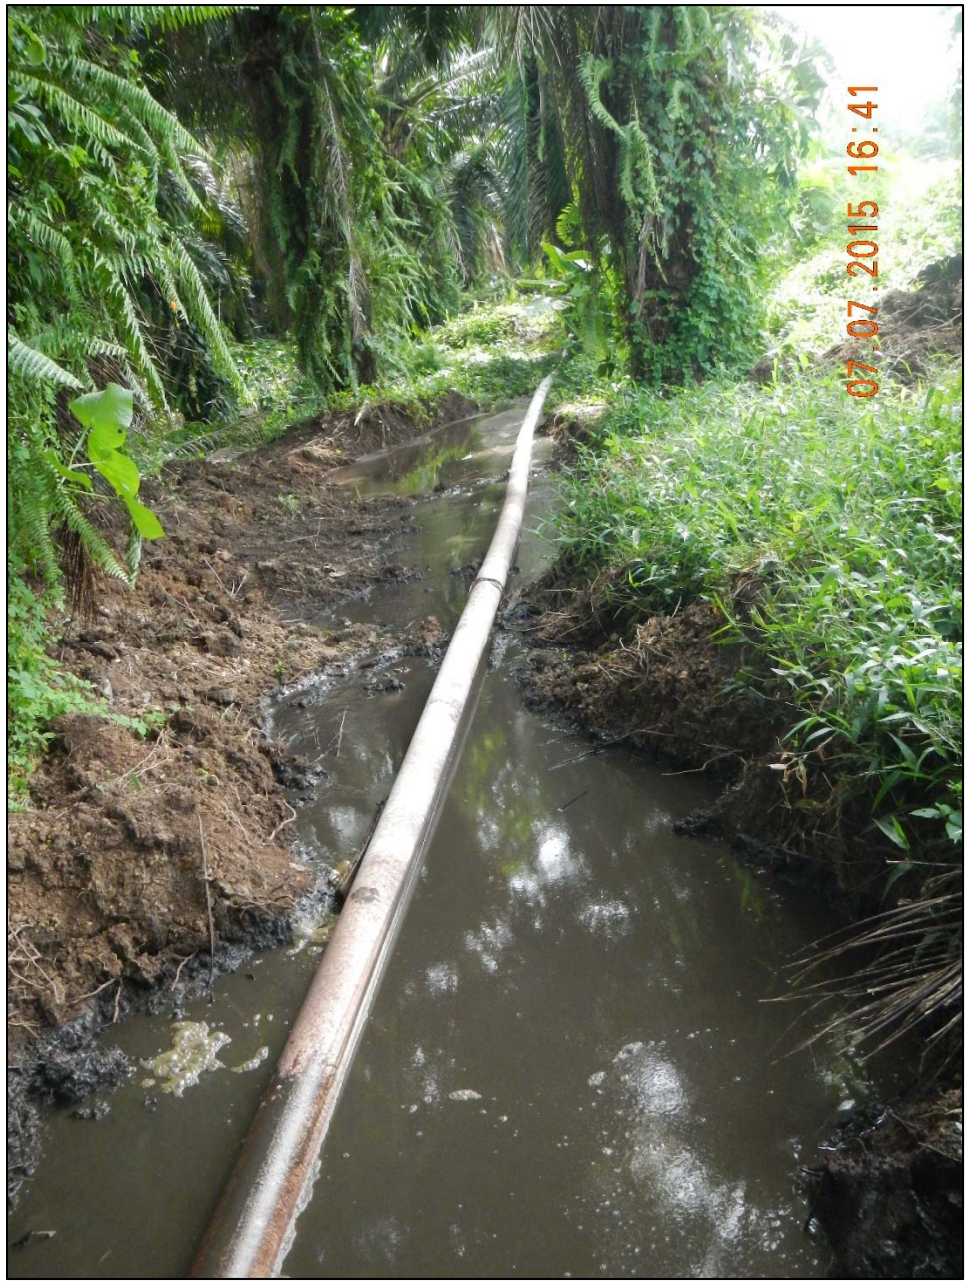
Photo No: 5
Date: 07/07/2015

Description:
View of the drainage channel of the bypass flowing toward the southwest. The Pasion River is located approximately 400 meters toward the south of the lagoon bypass location. Runoff flows downstream towards the river.

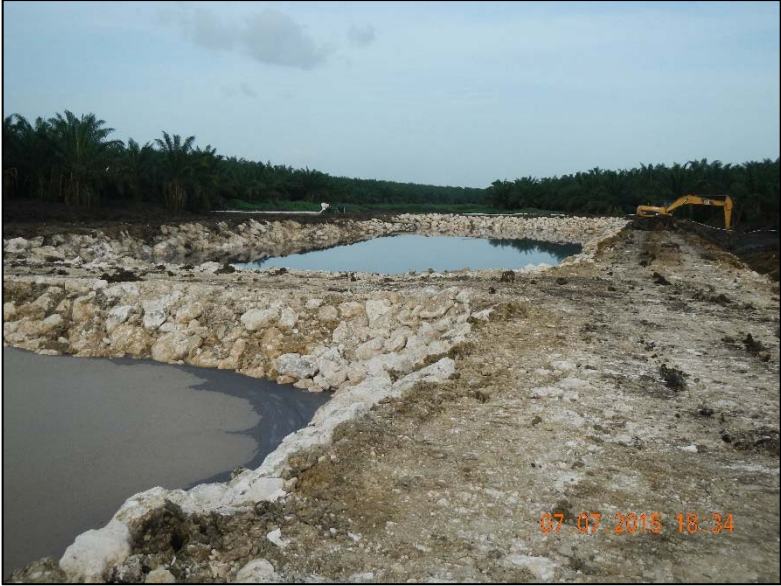
Direction Photo Taken: South			
Description: View of REPSA II's sludge digester lagoon (left) and final settling lagoon.

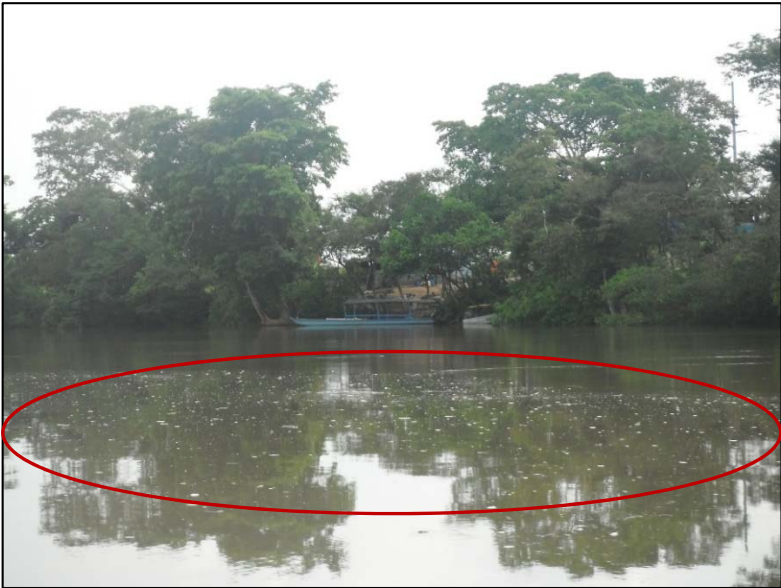
On July 8, 2015, EPA and MARN conducted a site reconnaissance on the Pasion River, near the cities of Sayaxche, El Ceibal, and Cedral. The river water appeared turbid. In addition, a large oil like sheen with debris was observed at the river water surface (See photo 9, page 21). EPA and MARN personnel observed sewage seeping from the ground and flowing directly into the Pasion River at the City of Sayaxche ferry area. (See photo 10, page 22). EPA also observed Sayaxche residents collecting water near the sanitary leaking area that reportedly will be used for some sort of human consumption (See photo 11, page 22).

Direction Photo Taken: North			
Description: View of debris accumulated in an oil sheen observed on the Pasion River. Surface water was observed turbid.

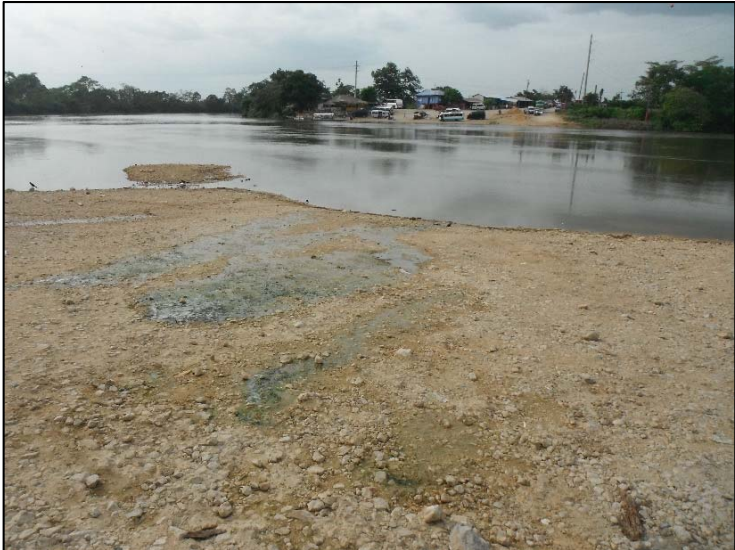
Direction Photo Taken: North			
Description: View of the sewage pipes seeping from the ground and flowing directly into the Pasion River. This was observed at the Sayaxche ferry area.

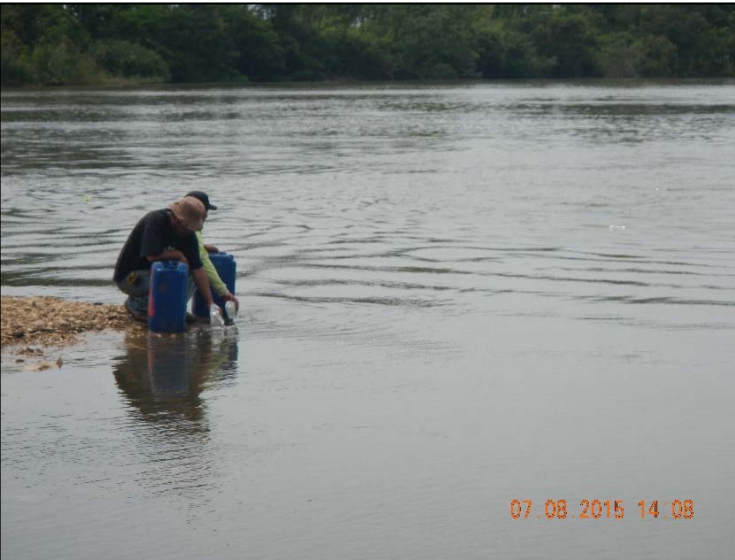
07.08.2015 14.08	
Direction Photo Taken: West			
Description: View of collection of water for human consumption near the sewage pipes location.

- EPA recommends performing follow up sampling activities near the populated areas to protect human health. Sample analyses should include (but not limited) BOD₅, total suspended solids, total metals, ammonia, total phosphorus, pH, dissolved oxygen, temperature, *E. coli*, and fecal coliforms. *E. coli* is a species of fecal coliform bacteria that is specific to fecal material from humans and other warm-blooded animals. Studies conducted by EPA to determine the correlation between different bacterial indicators and the occurrence of digestive system illness at swimming beaches suggest that the best indicators of health risk from recreational water contact in fresh water are *E. coli* and enterococci. EPA recommends *E. coli* as the best indicator of health risk from water contact in recreational waters (USEPA, 2015).
